Arborist Report

Venetia - Villa Vivaci HOA, Venice, FL

Cancello Grande Dr Venice, FL 34293

Friday, November 18th, 2022

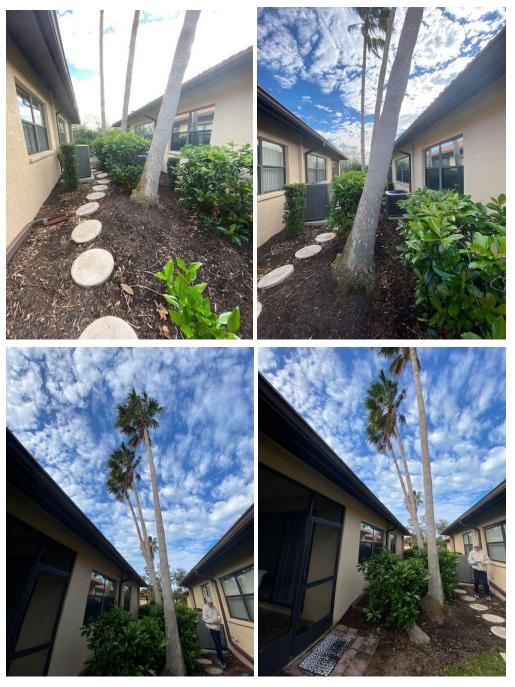
LOCATION #1 4563/4561 Cancello Grande Ave

Tree(s): Washingtonian Palms (Washingtonia robusta)
2 of the 3 are leaning at an approximate 15 degree lean towards 4563 Cancello G. Ave
Recommendation: Removal to mitigate risk of failure; full time target - house

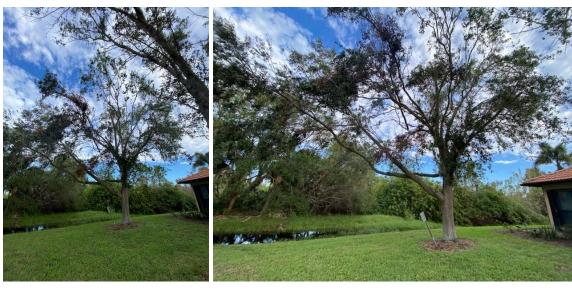
LOCATION #2 4526 Cancello Grande Ave

2 located to the left / SW of 4526 Cancello G. Ave; The Oak furthest the rear of parcel has noticeable storm damage.

Tree(s) have a decent amount of broken hangers from the hurricane. Remove broken branches greater than 1" diameter back to laterals or un-damaged tissue.

Recommendation: Pruning spec below -

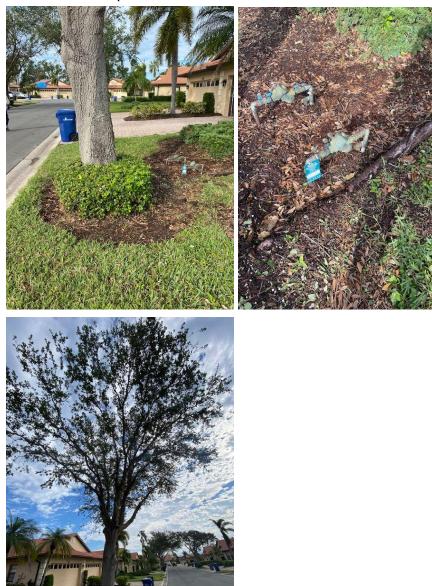
LOCATION #3 4125 Bella Pasque

Located front of parcel, street tree.

Recommendation: N/a; Tree is in good health. Unideal location due to adjacency to

major utilities. Monitor tree & utilities.

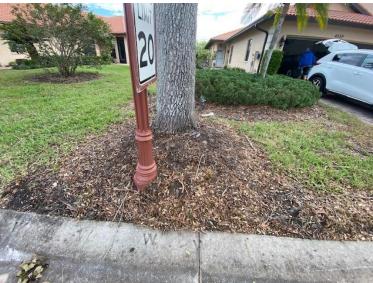
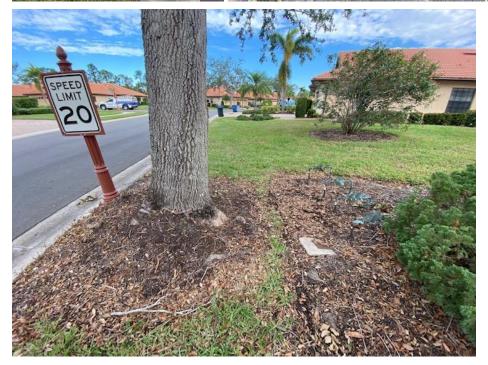
LOCATION #4 4559 Cancello Grande Ave

Located front of parcel, street tree.

Recommendation: N/a; Tree is in good health. Unideal location due to adjacency to major utilities. Monitor tree & utilities.

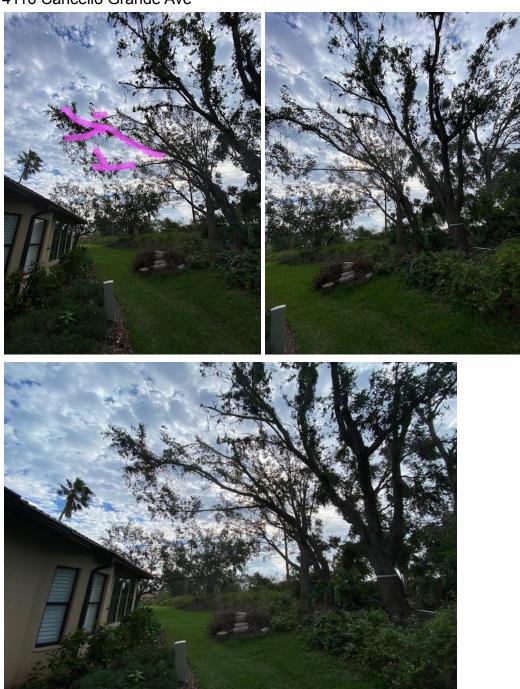
LOCATION #5 4116 Cancello Grande Ave

Located rear left of parcel.

Recommendation: Reduction pruning by approximately 25-30% away from structure.

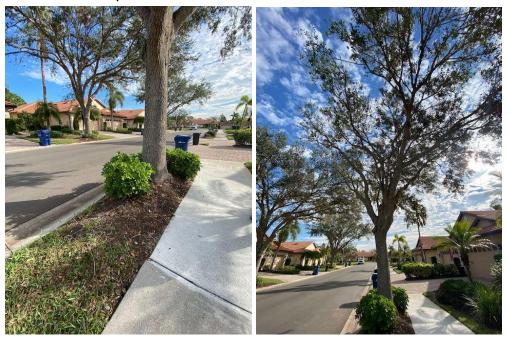
LOCATION #6 4134 Bella Pasque

Located front of parcel, "Street tree".

Recommendation: N/a; Tree is in good health. Unideal location due to limited root space

area. Monitor tree & sidewalk.

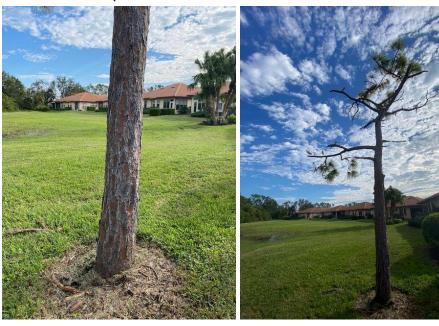
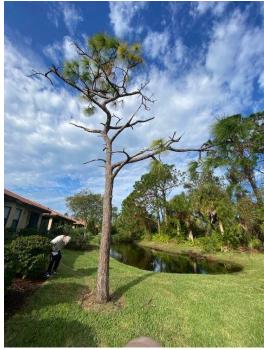
LOCATION #7 4139 Bella Pasque

Tree(s): FL Slash Pine Tree (Pinus elliottii)

Located rear of parcel

Recommendation: Tree removal; tree has approximately 10-14 % LCR, chlorotic needles, dieback in canopy. Tree is located within 20 ft of the residence.

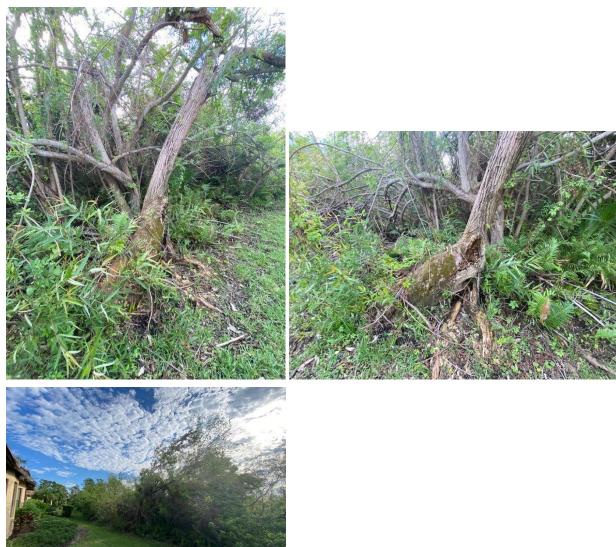
LOCATION #8 4543 Cancello Grande Ave

Tree(s): Wax Myrtle (Myrica cerifera)

Located rear of parcel

Recommendation: N/a; Tree is in *The Preserve*, not a high risk of failure towards

persons / property at this time.

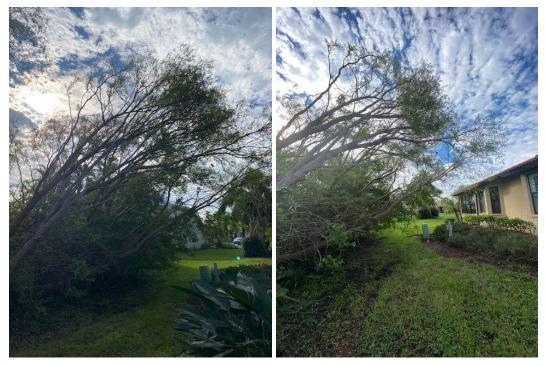
LOCATION #9 4571 Cancello Grande Ave

Tree(s): Wax Myrtle (Myrica cerifera)

Located rear of parcel

Recommendation: Cut back trees to *The Preserve*. Do not use equipment in *The*

Preserve, cut back by hand; Trees are leaning towards structure.

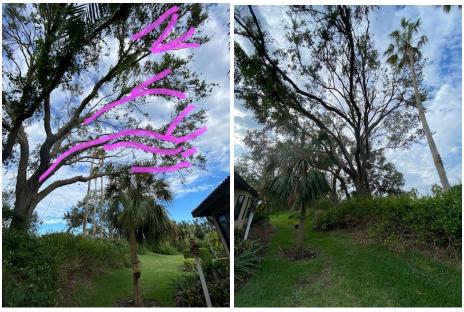
LOCATION #10 4110 Bella Pasque

Located rear left of parcel.

Recommendation: Reduction pruning by approximately 25-30% away from structure.
